**2002 34 Sea Ray Sundancer**

***Angie II***

# **Report of Marine Survey**

February 27, 2023

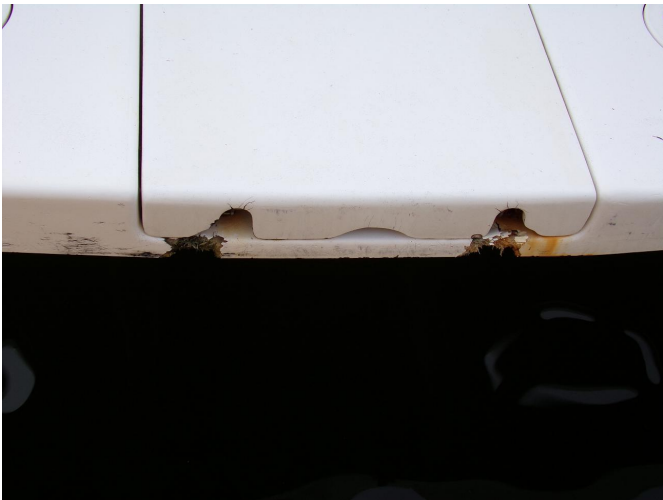
- \* **TRANSOM: [C1]** Reinforced, FRP slightly rounded with fiberglass swim platform. The platform has some impact damage in center near flip out swim ladder.

Damaged aft swim platform

*Further investigate and repair as necessary.*

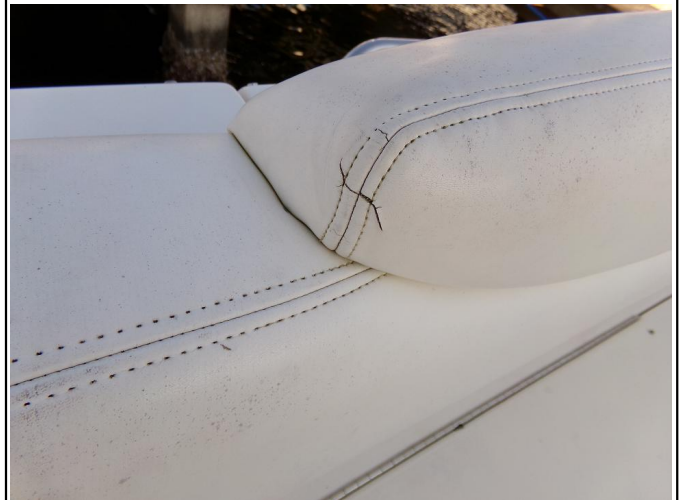
- \* **NOTE: [C2]** Deck area deficiencies and observations:
  1. Silicone on arch is moldy.
  2. Aluminum frame for windshield paint bubbling and chipping.
  3. White vinyl seating is moldy/dirty/ with some cracking in some areas of seats.
  4. Steering wheel missing cap.
  5. Helm electronics are not operable with screens on machines discolored.
  6. Helm gauges have condensation.
  7. Bow anchor locker hatch fiberglass is chipping off around latch.

Cockpit seat cracking

*Investigate further and repair or renew as necessary.*

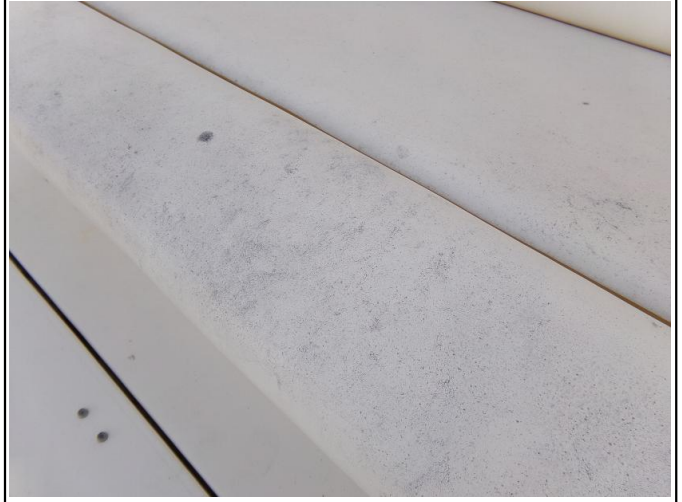
Cockpit moldy seat

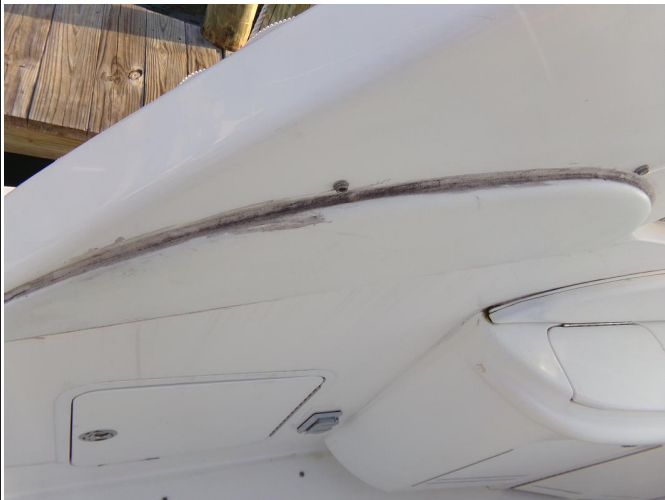
Radar arch silicone

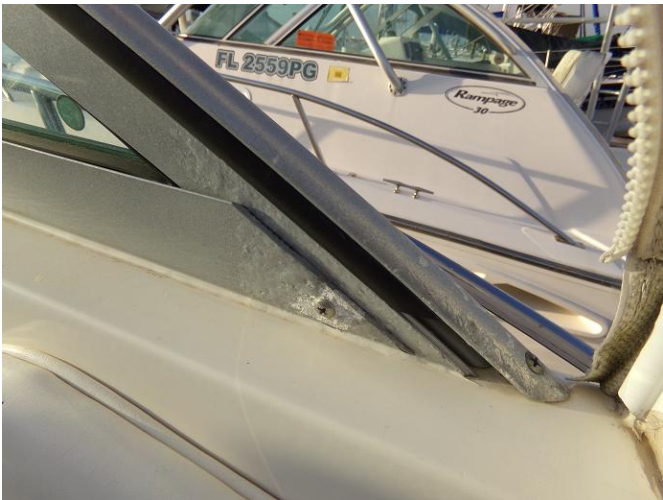
Windshield frame

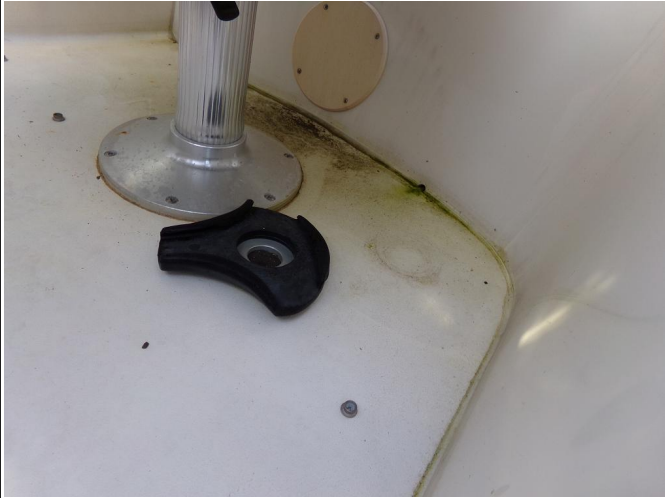
Helm broken chair

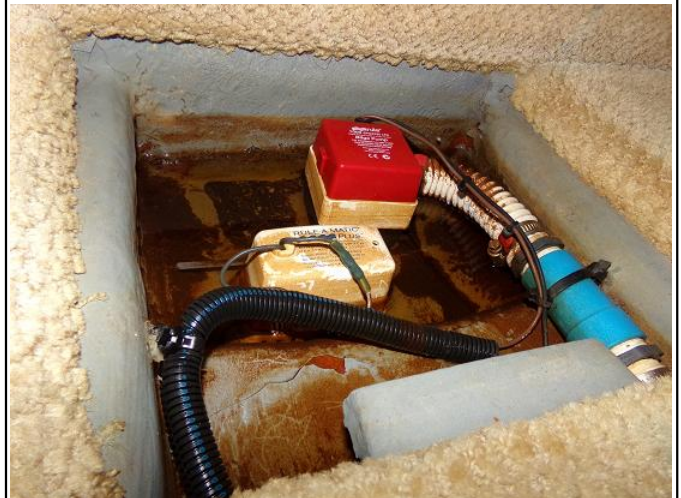
- \* **BILGE/LIMBER HOLES: [B1]** A smooth gelcoat surface was used in the shallow bilge area. Bilge has 4-5" of water in aft and cabin bilges due to the bilge pumps not being operable due to dead batteries.

Cabin bilge

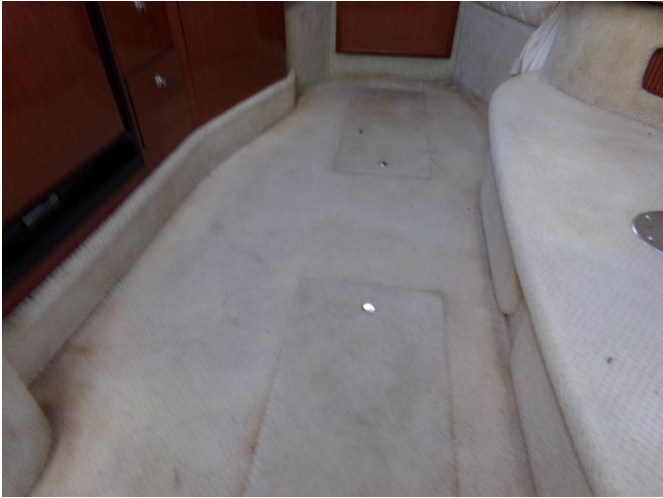
The v-berth mattress has water stains from hatch overhead leaking on bedding. The tan carpet in the cabin is very dirty.

Cabin carpet

*Investigate further and repair or renew as necessary.*

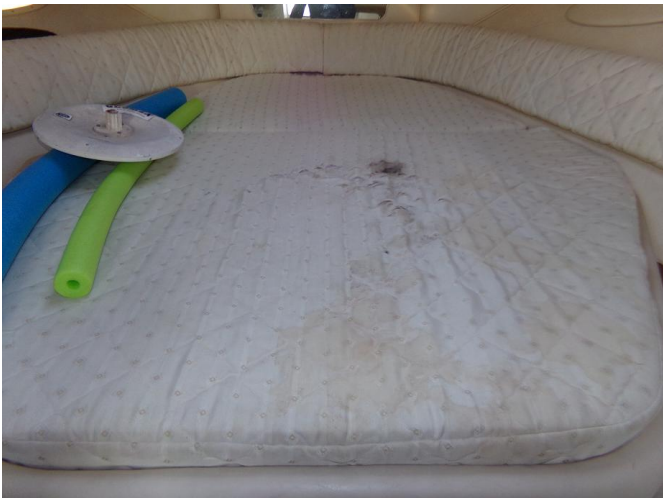
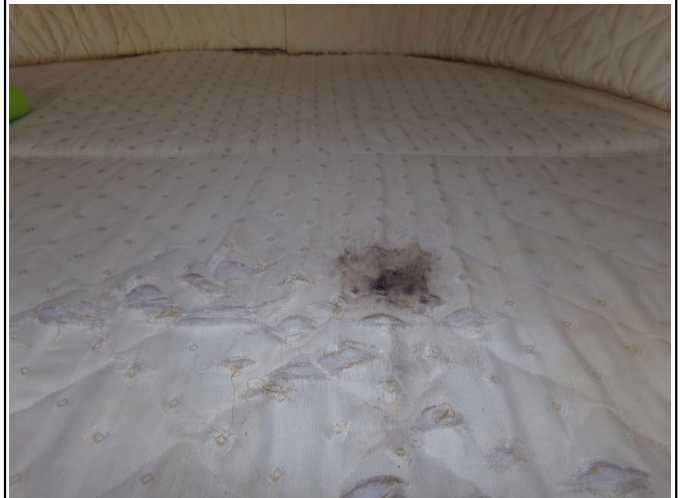
V-berth mattress

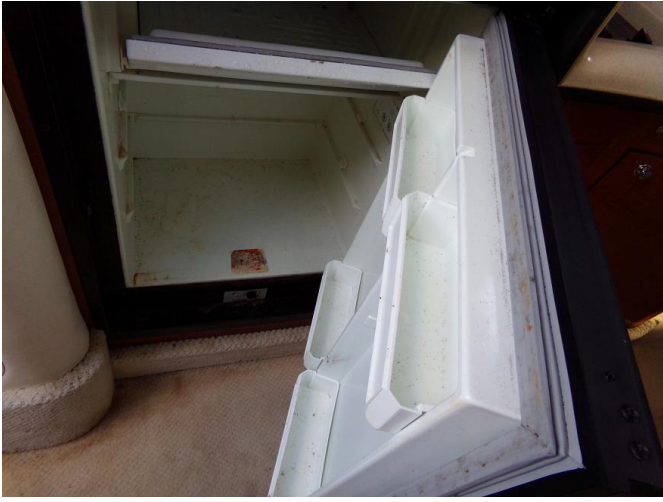
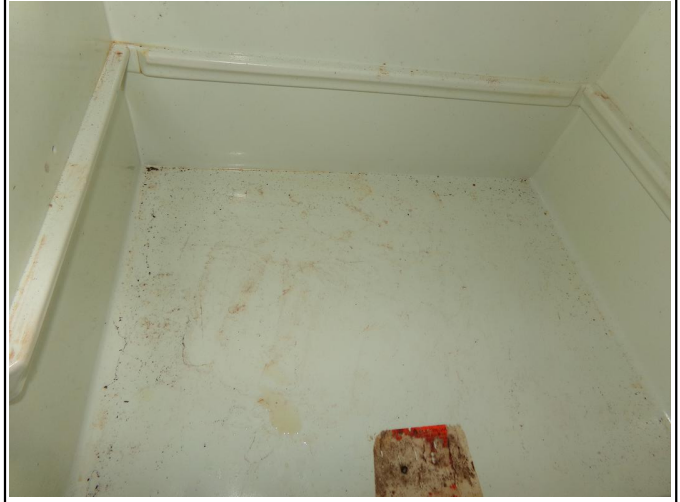
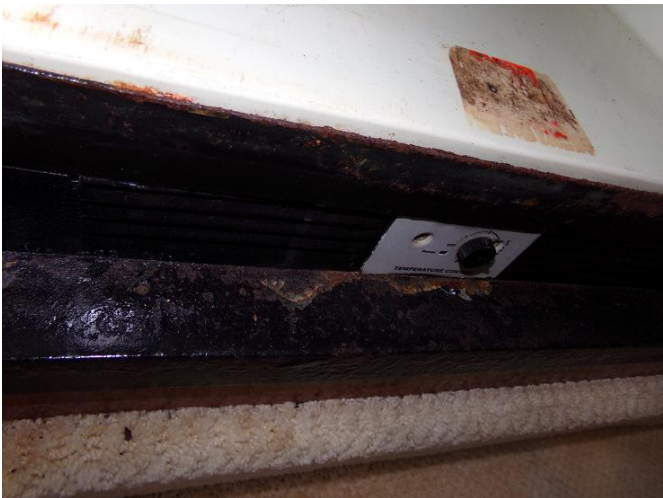
Norcold refrigerator. The frame was rusty and inside the refrigerator was moldy. Does not appear to be operable.

Cabin refrigerator frame

*Investigate further and repair or renew as necessary.*

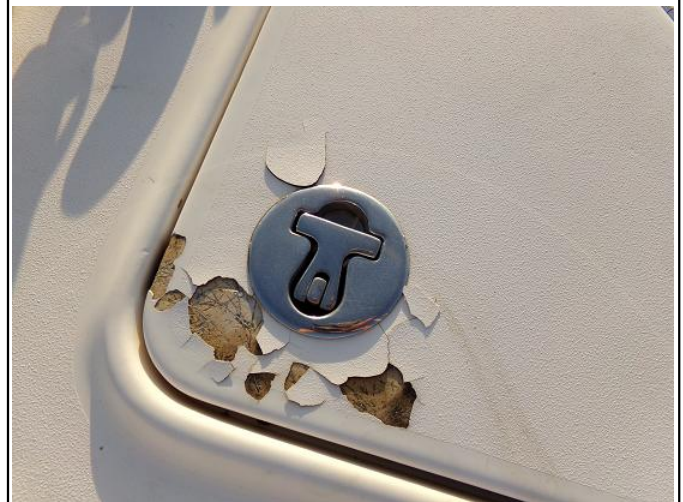
Anchor locker hatch

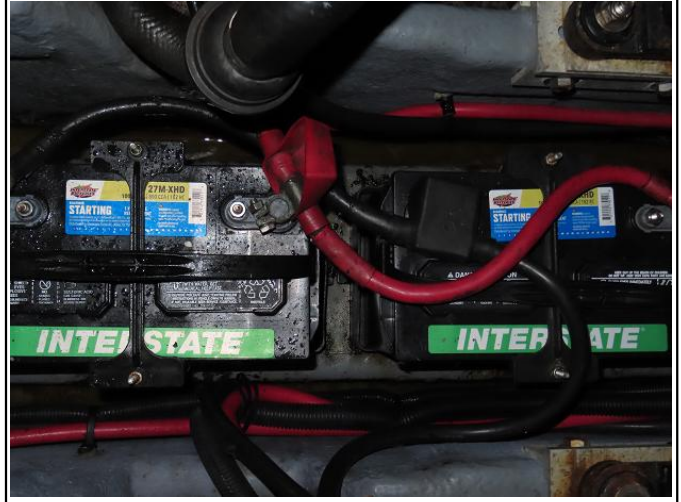
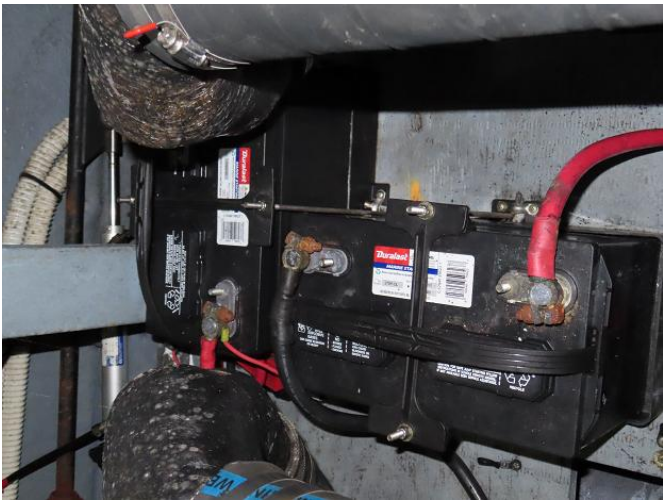
All batteries were dead at the time of sea trial.

Batteries

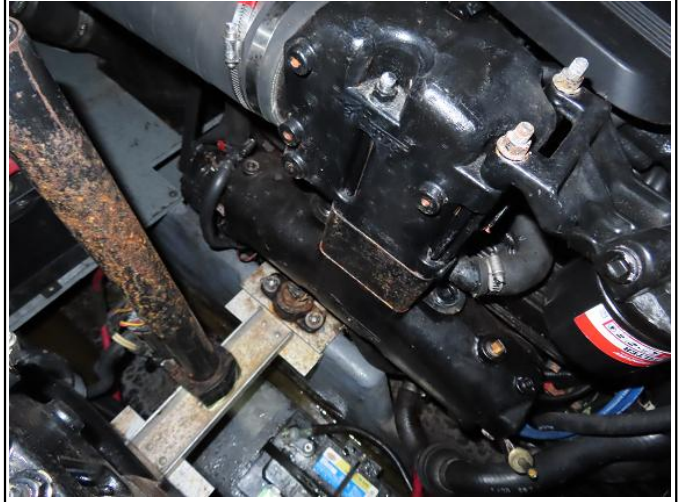
Engines are in fair condition with some rust and corrosion on tops of engines, engine exhaust risers, and engine mounts.

Starboard engine exhaust riser

*Investigate further and repair or renew as necessary.*

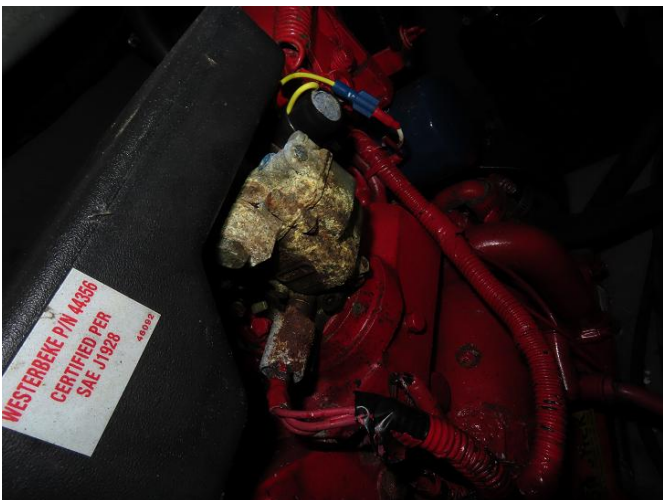
- \* **TYPE/MANUFACTURER: [B3]** Single Westerbeke gas generator. Part number 44356.  
The carburetor is very corroded and generator was not tested due to dead batteries.

Generator corroded carburetor

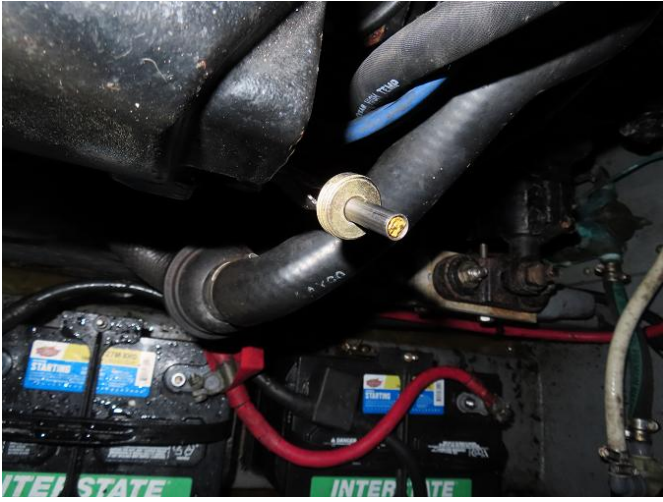
- \* **LUBRICATION: [B2]** The dipstick on the port engine is broken off and the dipstick for the starboard engine is about to break off.

Port engine broken dipstick

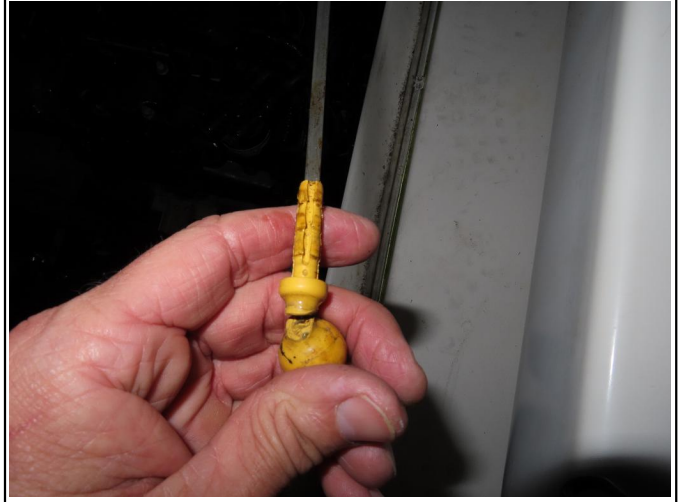
Starboard engine almost broken dipstick
