**2002 34 Sea Ray Sundancer**

***Angie II***

# **Report of Marine Survey**

February 27, 2023

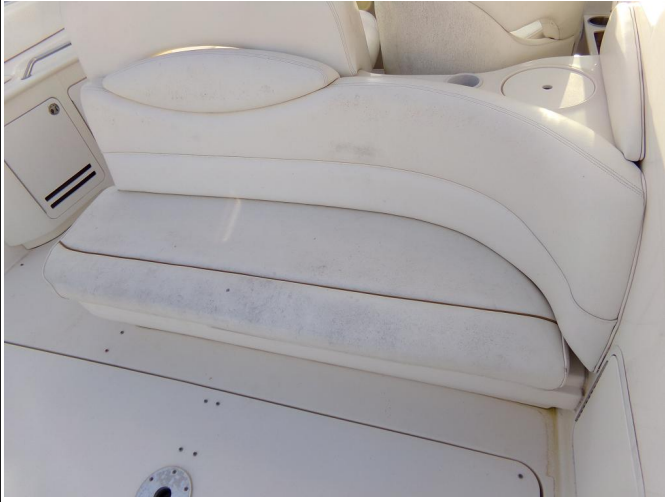
Cockpit seating

- \* **NOTE: [C2]** Deck area deficiencies and observations:
  1. Silicone on arch is moldy.
  2. Aluminum frame for windshield paint bubbling and chipping.
  3. White vinyl seating is moldy/dirty/ with some cracking in some areas of seats.
  4. Steering wheel missing cap.
  5. Helm electronics are not operable with screens on machines discolored.
  6. Helm gauges have condensation.
  7. Bow anchor locker hatch fiberglass is chipping off around latch.

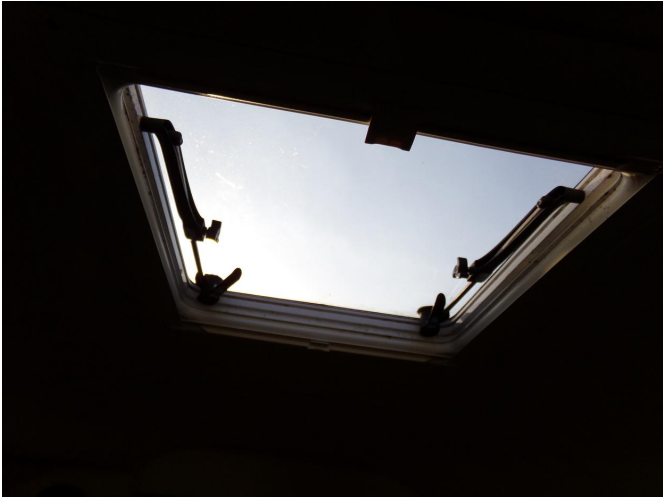
V-berth hatch

- \* **AIR CONDITIONING: [C3]** One (1) Cruisair self contained unit with digital control. Powers up but compressor for AC appears to not be operable.
- \* **NOTE: [C4]** The v-berth mattress has water stains from hatch overhead leaking on bedding. The tan carpet in the cabin is very dirty.

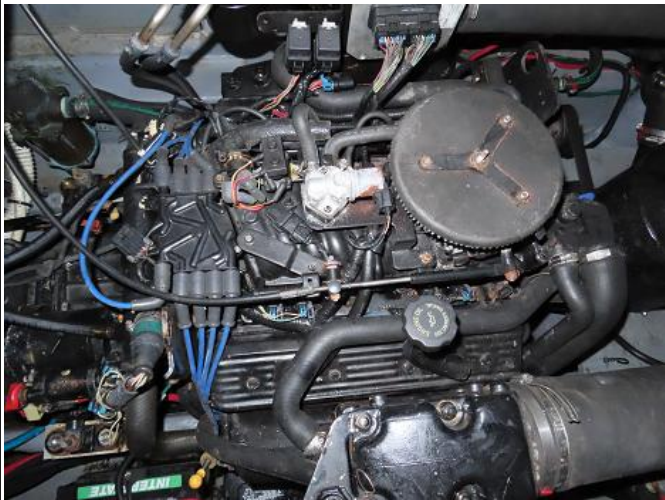
Port engine

- \* **OVERALL CONDITION: [C7]** Engines are in fair condition with some rust and corrosion on tops of engines, engine exhaust risers, and engine mounts.

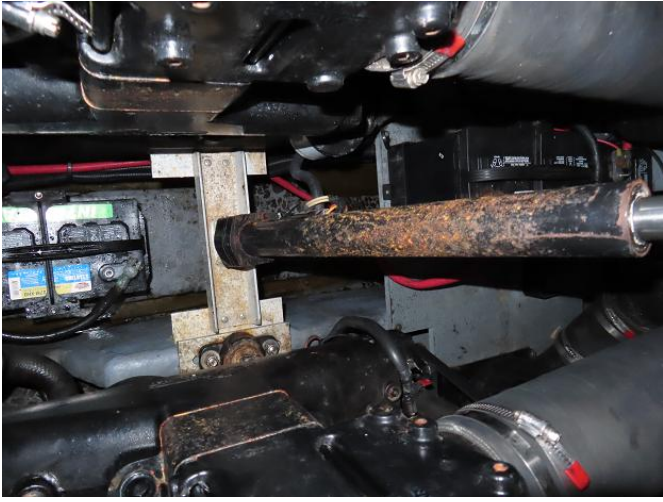
Engine room hatch pump

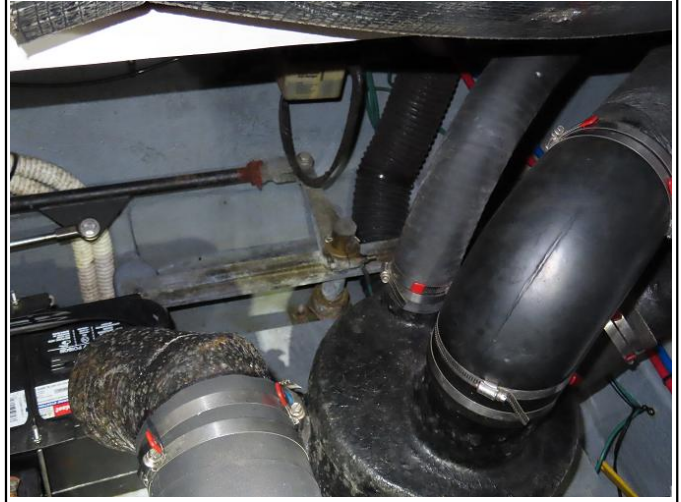
Main engine exhaust

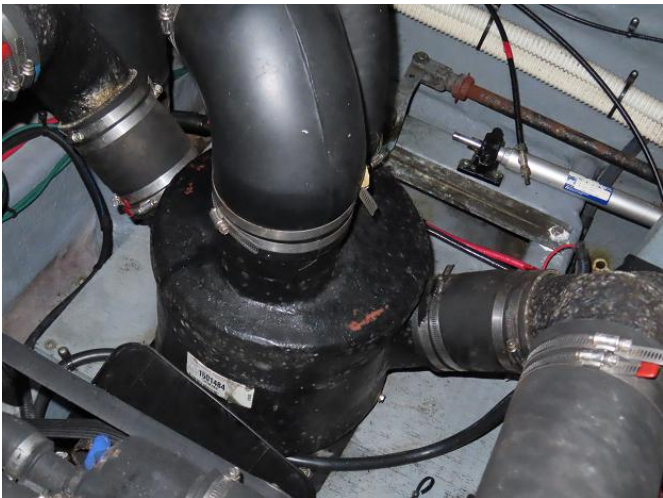
Main engine exhaust

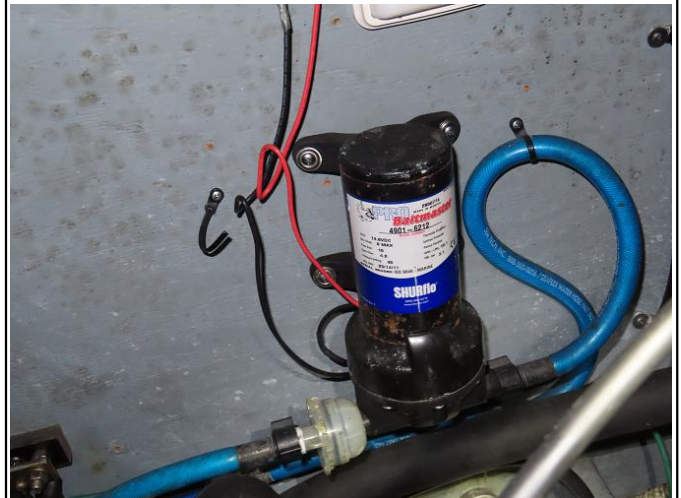
Freshwater pump

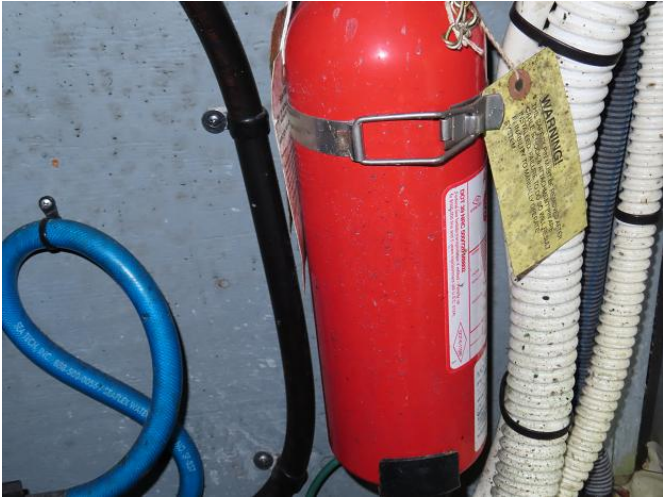
Engine room fire suppression

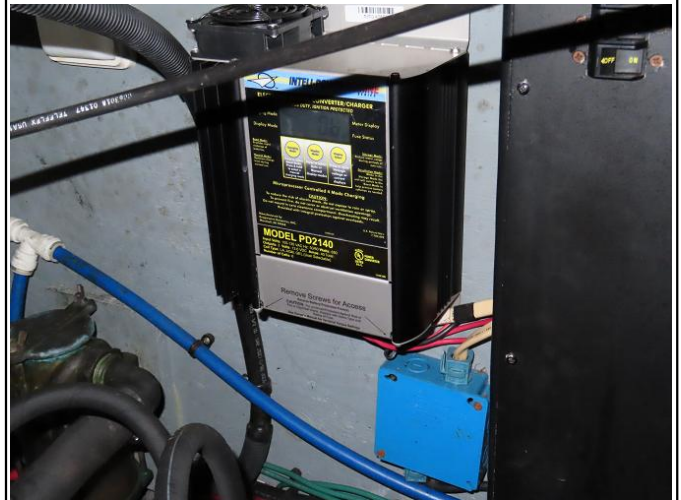
Battery charger

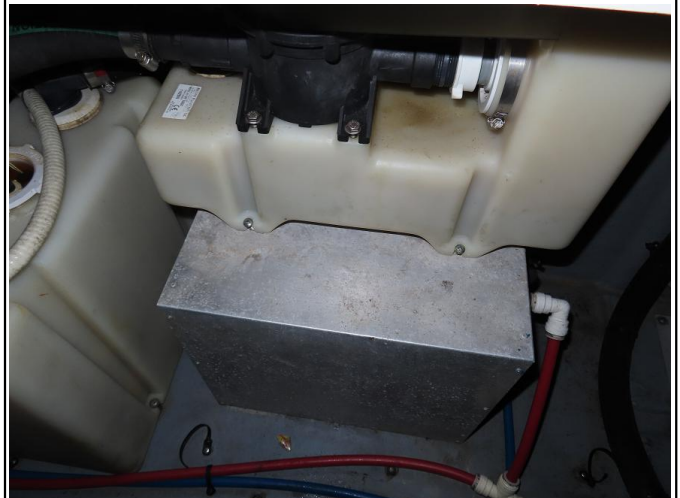
Water heater

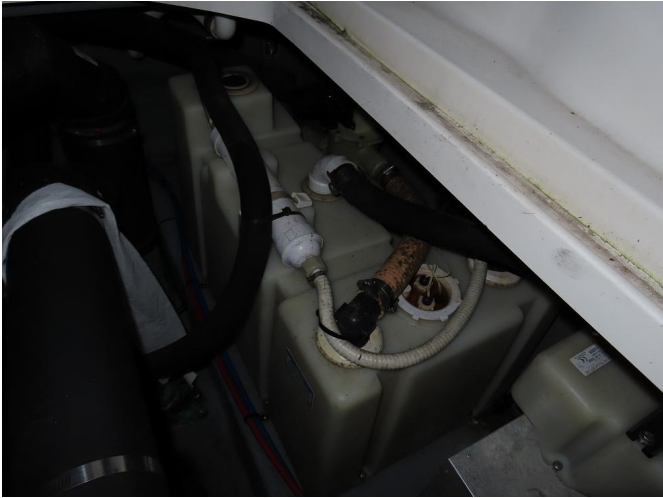
Waste tank

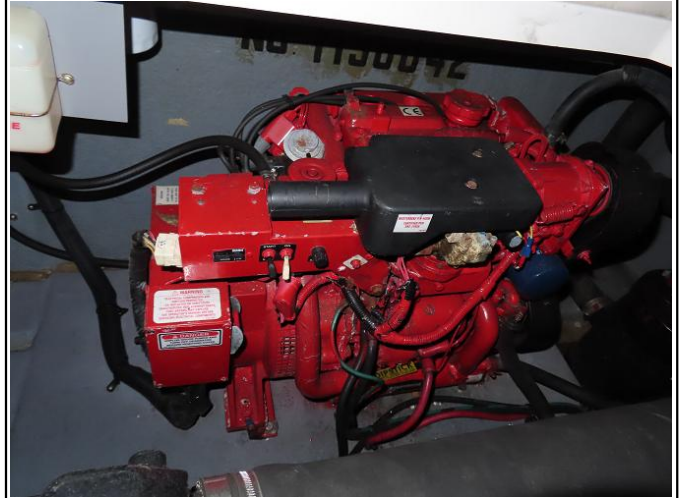
Generator

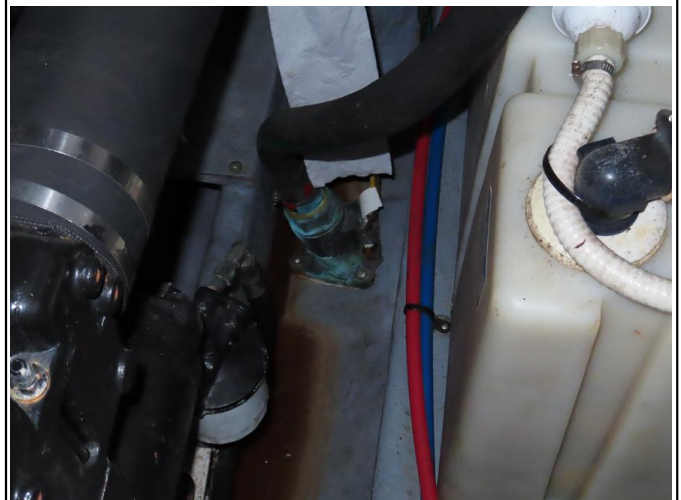
Waste sea cock
